Technical Report 32-1039

Storage Tests of Nitrogen Tetroxide and Hydrazine
in Aluminum Containers

JET PROPULSION LABORATORY

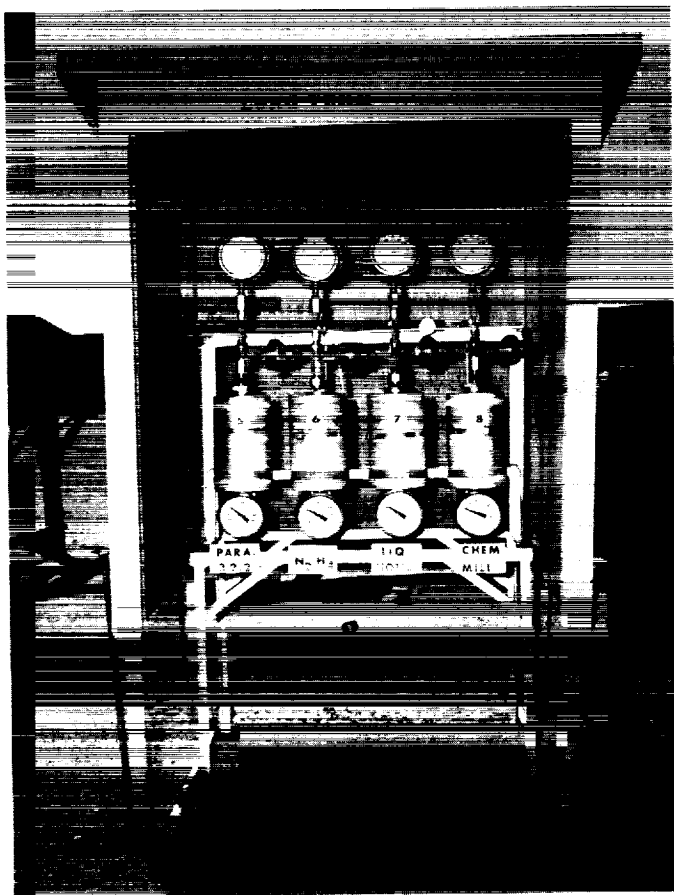
Fig. 6. Typical canister storage test installation

Instrumentation similar to that used for the previous tests (described in Section IV) was installed on each canister. Instead of the explosively-actuated valves, however, every canister was fitted with a burst-disc assembly for protection against excessive pressure build-up. Each of the canisters was loaded with 2134 milliliters of anhydrous hydrazine. All eight canisters were then placed in a vertical orientation in shade at JPL's Edwards Test Station facility. Figure 6 shows four of the canisters in the storage shed. Readings of canister pressure, liquid temperature, and ambient temperature were taken twice each working day for 2 months. Recorded

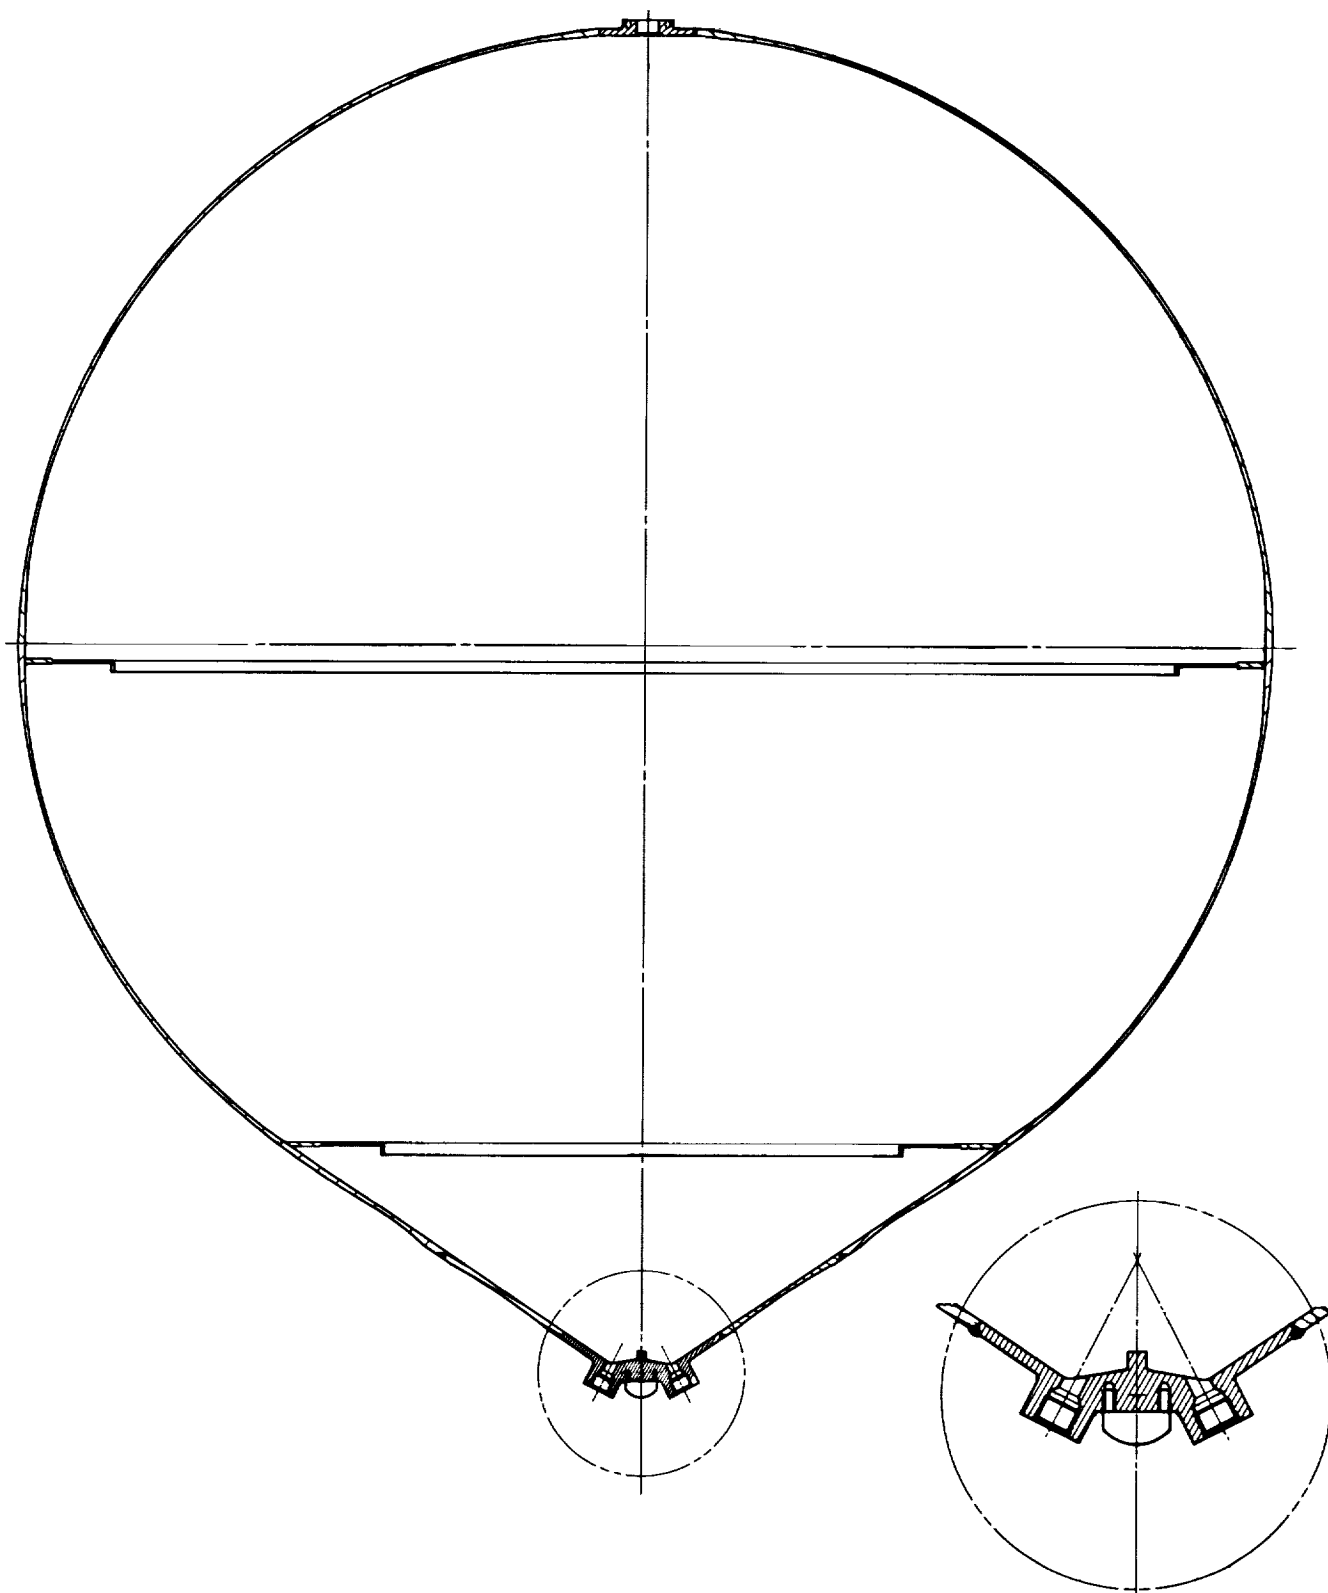
Fig. 11. Section view of Vega fuel tank used for long-term storage test of hydrazine

Upon receipt at JPL, the tank was proof-tested and fitted with the necessary appurtenances for the test. These included a bourdon-type pressure gauge and two vent valves connected to the top port of the tank, a standpipe running from one of four bottom ports up to the middle of the tank (for securing propellant samples from the center of the propellant bulk), a dial thermometer inserted through another of the bottom ports, and two drain valves, plus miscellaneous necessary fittings attached to the bottom ports. All of these articles were constructed of aluminum, stainless steel, and/or Teflon. All seals were Teflon. Each of these parts was carefully cleaned before installation.

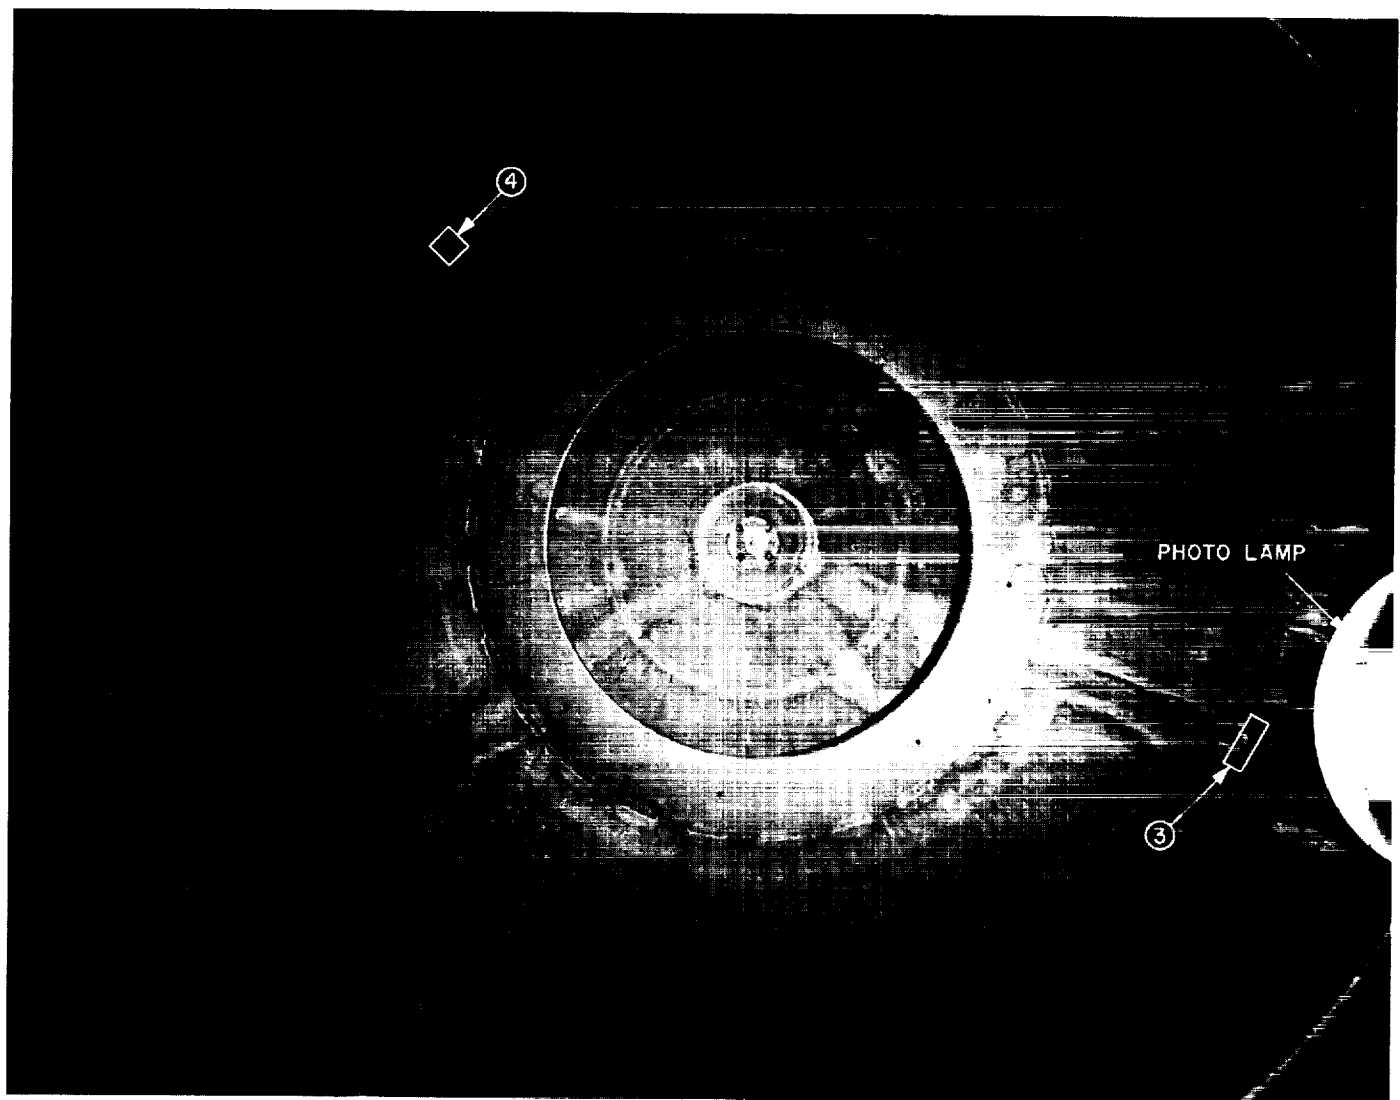
Fig. 13. Interior lower surface of Vega fuel tank after long-term hydrazine storage test and locations where metallographic samples No. 3 and No. 4 were taken

with a small amount of water and cut open for inspection. Many areas on the internal surface appeared to be discolored. In a random manner, the colors of the splotches were almost white, yellow-gray, blue-gray, and green-gray. In general, the dominant markings appeared as if a semi-liquid material had oozed out of the tank wall and drained downward toward the bottom of the tank. There were also some diffused circular rings, faintly resembling water level marks around a lake; these were probably related zones of variations in the metal surface, or a structural condition caused by the fabrication process. Since the inside of the tank was not seen until several weeks after having been drained, it is not known for certain what changes in the surface

took place between the time it was drained and when cut open. Figures 13 and 14, although lacking color definition, convey a good impression of the appearance of lower and mid-section parts of the surface at the time it was first inspected.

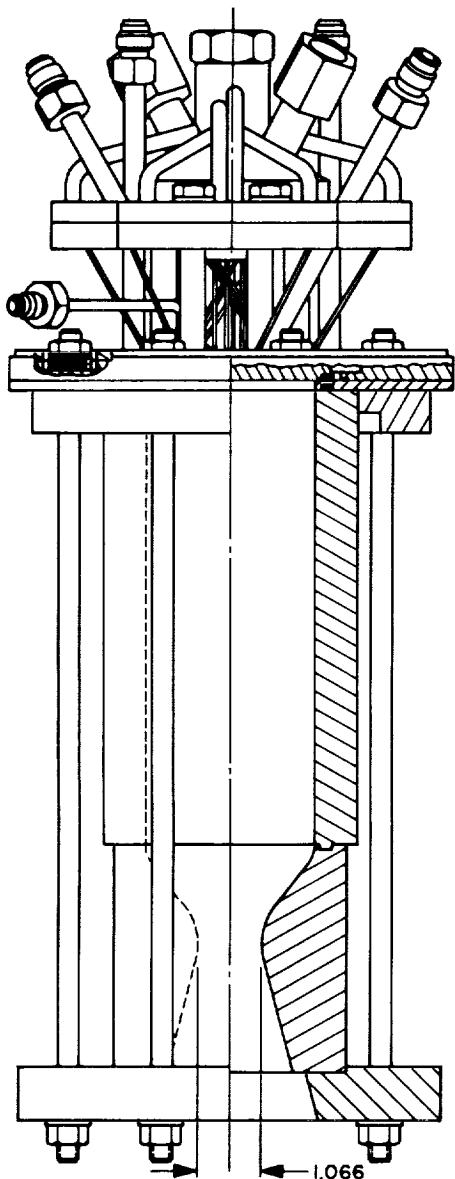
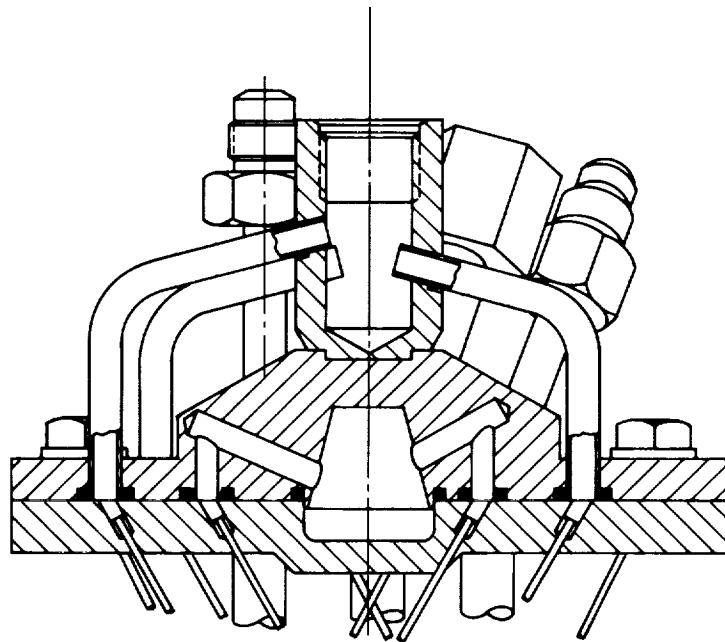
Fig. 21. Design of uncooled test rocket engine used to make comparison firings with stored and stock hydrazine fuel

In order to detect differences in performance and combustion smoothness between the stored and regular stock hydrazine when burned with N_2O_4 , a series of six rocket engine firing tests was made using the JPL MOD IV 100-pound thrust injector and a heavy, uncooled thrust chamber of 42 inches L^* . That injector was chosen for the tests because of its demonstrated reproducibility, from firing to firing; some data on this injector are given in Ref. 4. Figure 21 shows a cross-section view of the test engine assembly. The firing tests were made at JPL's Edwards Test Station with the engine installed (Fig. 22). To maximize the validity of the comparison, no changes in hardware were made during the series of six firings.

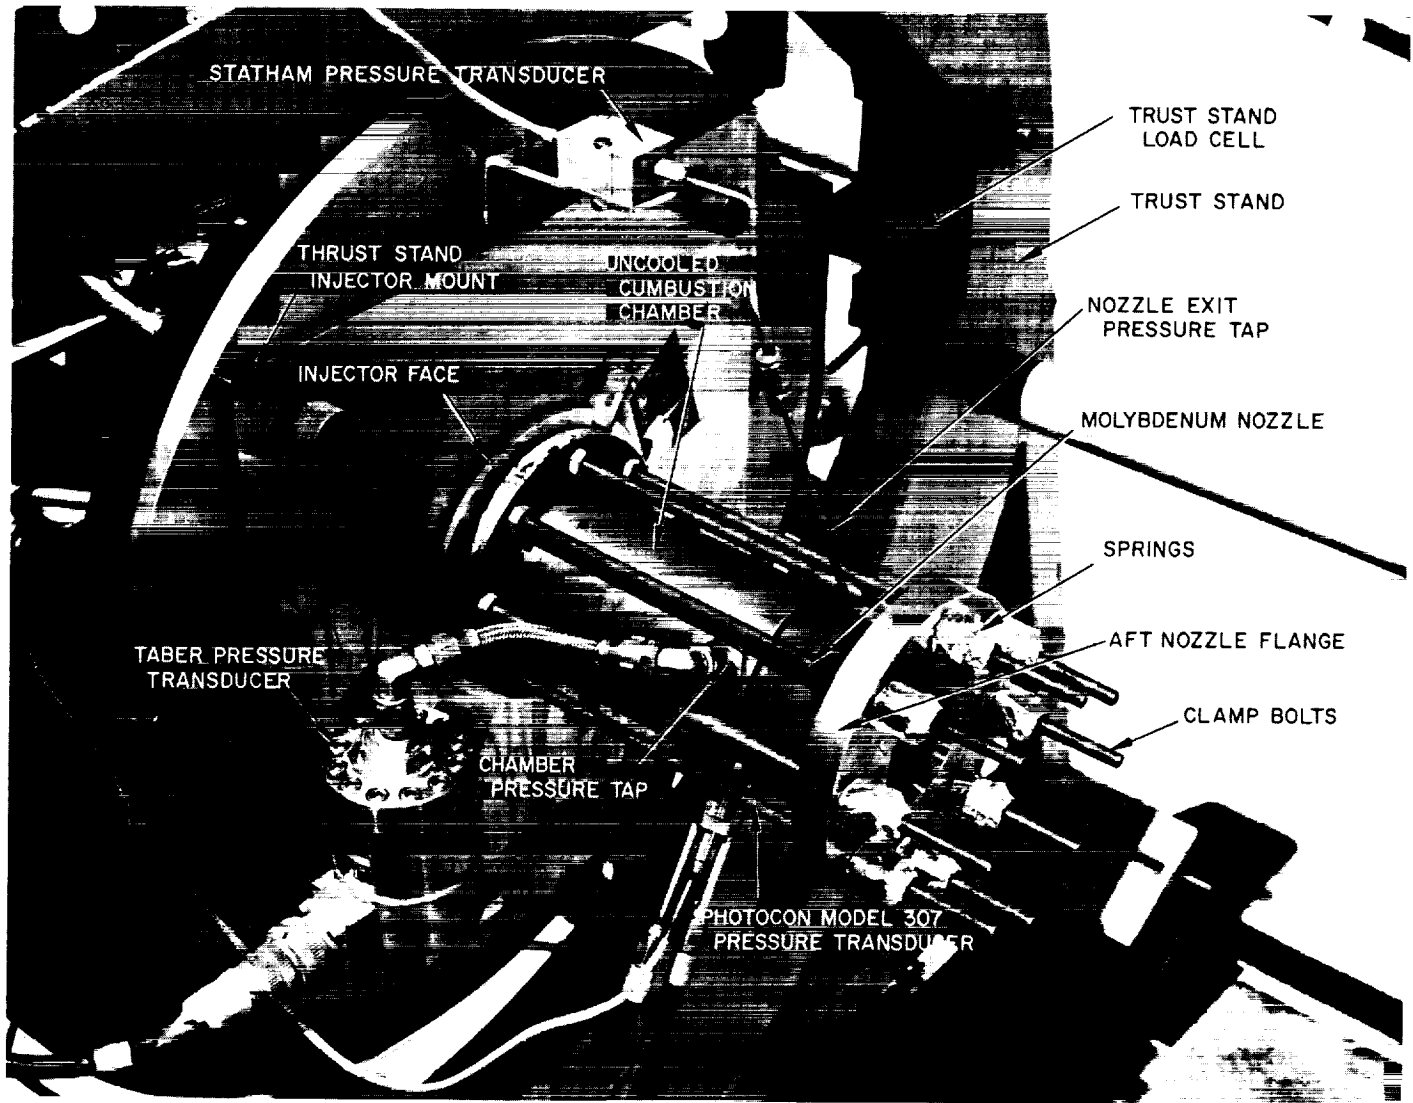
Fig. 22. Uncooled rocket engine on test stand at JPL's Edwards Test Station

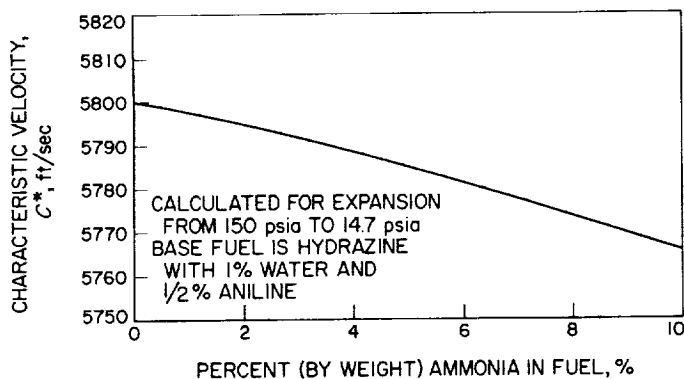
Fig. 23. Variation in theoretical shifting equilibrium c^* with addition of ammonia to hydrazine-base fuel burned with N_2O_4 at $r = 1.2$

Lewis Research Center. The program compared test results with theoretical loss in performance to be expected with increasing amounts of water and ammonia in the fuel; the changes in theoretical shifting equilibrium c^* with added ammonia and water are shown as plots in Figs. 23 and 24. The plots show that water added to pure hydrazine causes a drop of 15 ft/sec in c^* for each percent (by weight) of water in the resulting solution. Based on that figure, the difference in measured water concentrations would cause the stored fuel to deliver 9 ft/sec less c^* than stock fuel. Dissolving ammonia into the fuel has a lesser effect, since ammonia is a good fuel itself; each percent (by weight) of ammonia in the chosen base fuel (hydrazine with 1% water and $\frac{1}{2}\%$ aniline) lowers the c^* by only about 3 ft/sec.

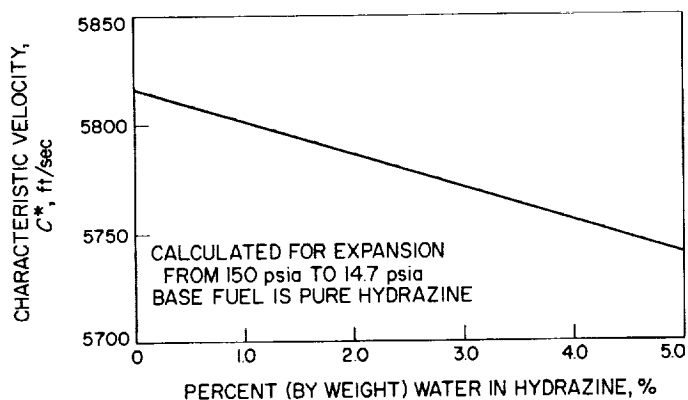
Fig. 24. Variation in theoretical shifting equilibrium c^* with addition of water to hydrazine when burned with N_2O_4 at $r = 1.2$
